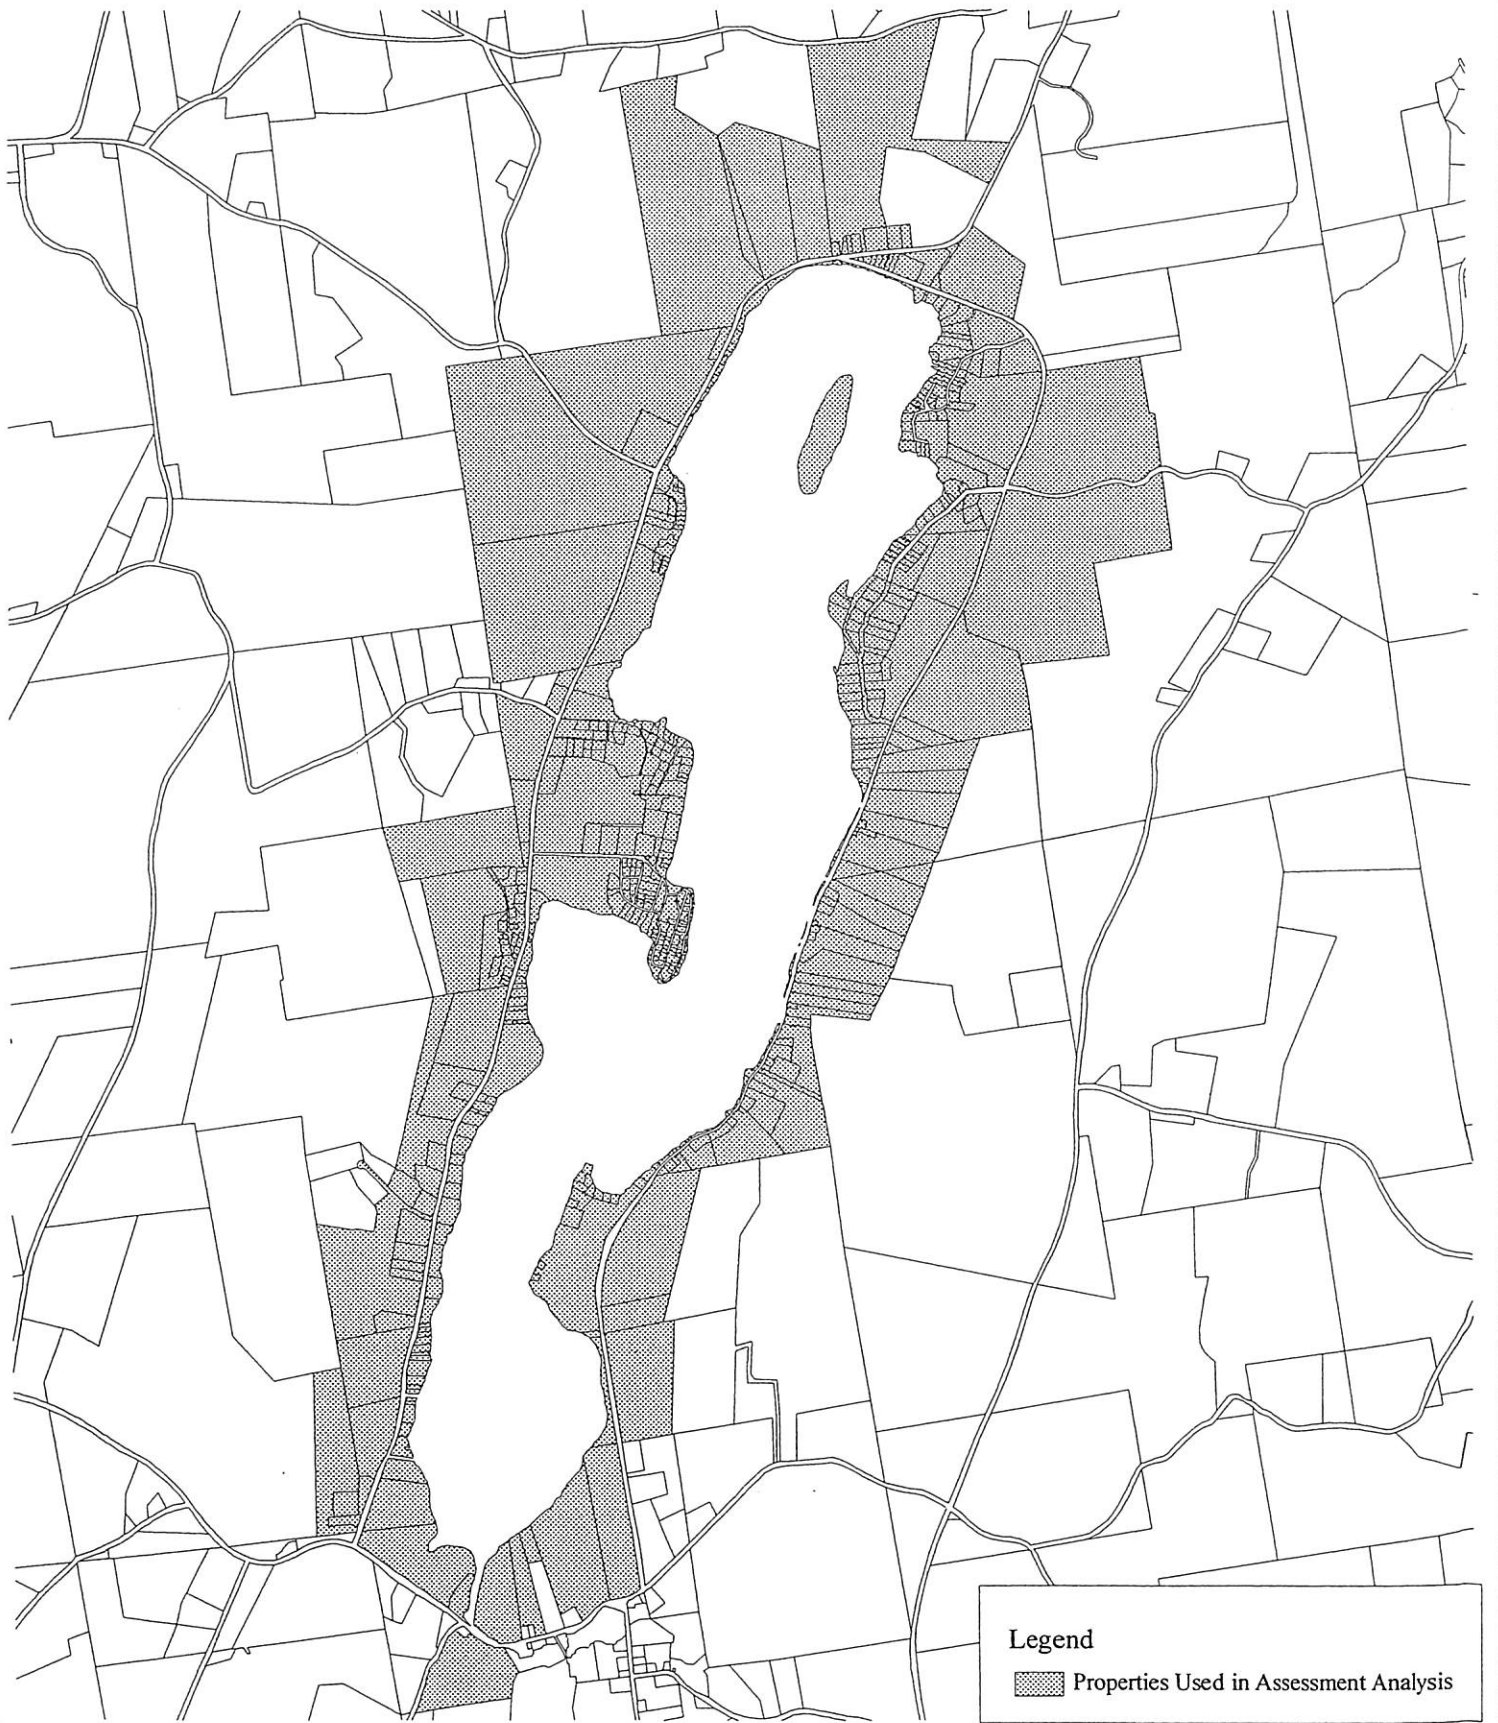
Figure 12
Property Map
Cossayuna Lake
Washington County, NY

There are no actual statistics for each portion of the Argyle and Greenwich population's who live in the watershed. However, the Washington County Geographical Information System Cooperative prepared the watershed mailing list of 650 from tax maps after omitting any duplicate ownership of property. Assuming that an average of 2.5 persons occupy each household, there are an estimated 1,625 persons residing in the watershed either part-time or year-round. Figure 12, "Cossayuna Lake Property Map," indicates the boundary for determining watershed population.

Real property along the shore and near-shore area annually generates approximately \$311,000 in revenues for the Argyle Central School, \$210,000 in town and county taxes within the town of Argyle, and \$38,000 in town and county taxes within the town of Greenwich. The small amount of area included in the Greenwich School District was not calculated for the purposes of this study. Figure 12, "Cossayuna Lake Property Map," illustrates the property boundaries represented by the figures above.
